IB188

Release Bearing Installation

Chevrolet and GMC applications, 1995 and older.

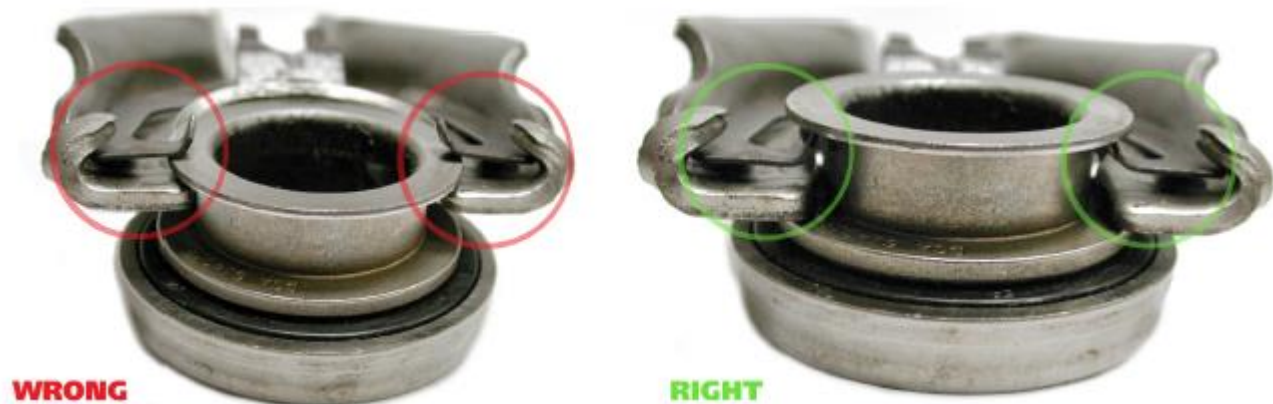
The clutch release fork spring tabs must be installed under the rear flange of the bearing, never behind the rear flange. Incorrectly installed will cause:

1. The clutch will not release correctly.
2. Release bearing and clutch fork may be damaged.
3. Mechanical or hydraulic release system components may also be damaged.
