DID YOU KNOW?

ADVICE FOR THE PROFESSIONAL

Overview

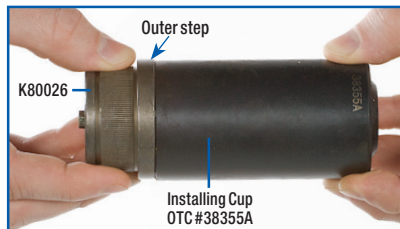
UPPER BALL JOINT - CORRECT

Correct fit, against outer step

These ball joints press in and apply force on the stud end of these applications. It is important that the installation cup be placed on the outer step of the ball joint housing. Pressing in the ball joint with force against the inside lip may push the lip and lower bearing into the stud, causing binding and premature failure. Always press in these ball joints using the outer step.

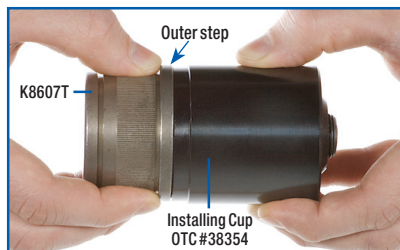
LOWER BALL JOINT - CORRECT

Correct fit, against outer step

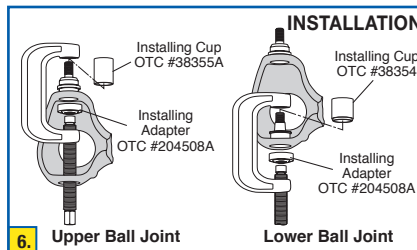
6. Upper Ball Joint

Incorrect fit, not against outer step

1. Clean the knuckle ball joint mating surfaces thoroughly.
2. Apply a suitable lubricant to the ball joint mating surface and assemble the ball joint into the knuckle.
3. Assemble the ball joint press components as shown in Fig 6. Check the alignment of all components. Tighten the forcing screw until the ball joint is firmly seated.
4. Install the snap ring on the upper ball joint.
5. Repeat Steps 1-3 to install the lower ball joint. Install the snap ring.
6. Install the knuckle assembly to the vehicle according to the vehicle service manual procedures.

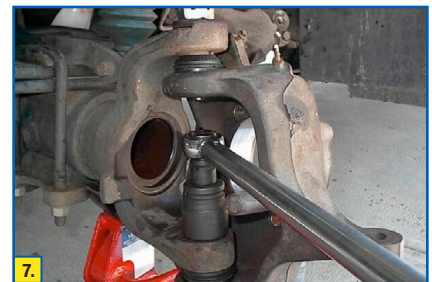
Tighten the LOWER ball joint nut to **59 Nm (44 ft. lbs.)** DO NOT USE AN IMPACT WRENCH. An impact wrench can spin the stud at high speed and cause premature failure. (FIG 7)

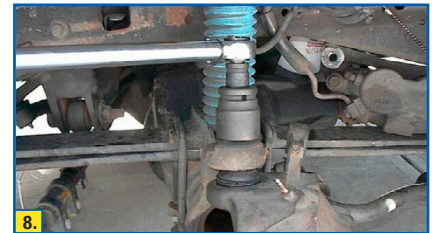
Tighten the UPPER ball joint nut to **94 Nm (69 ft. lbs.)** DO NOT USE AN IMPACT WRENCH. An impact wrench can spin the stud at high speed and cause premature failure. (FIG 8)
