OFFICIAL STEERING & SUSPENSION OF NASCAR®

On the affected vehicles, improper installation of a new hub assembly may cause an ABS, cruise control and/or VDC (Vehicle Dynamics Control) fault code to occur.

SUBARU	Legacy Outback	2005-2014
--------	-------------------	-----------

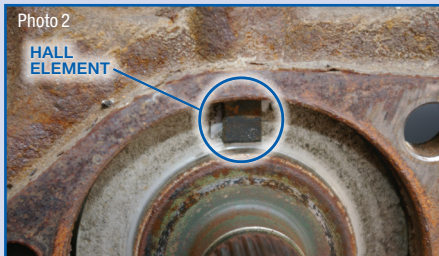
Photo 2

As the wheel rotates, the encoder ring's small magnetic strips (Photo 1) create pulses that the speed sensor's Hall element (Photo 2) picks up and outputs at a frequency proportional to the wheel speed. Each wheel's speed signal is transmitted to the ABS and/or VDC module (depending how the vehicle is equipped), then to the ECM (Engine Control Module). Cruise control is managed by the ECM.

HALL  
ELEMENT

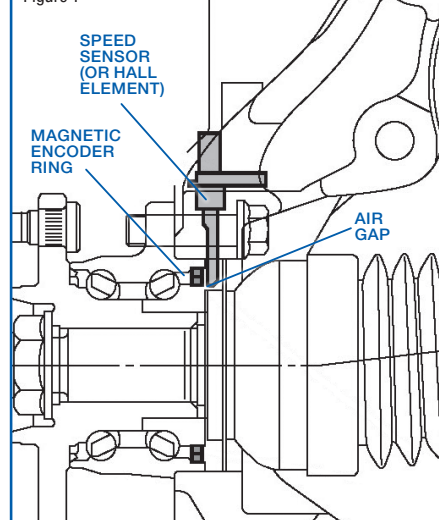
Figure 1

Check for rust. Any rust present on the mounting area or on the backing plate can keep the bearing assembly from being fully seated (even when torqued down), creating an excessive "air gap" between the encoder and the sensor. It only takes a few extra thousandths of an inch to trigger the false error codes. (Fig. 1)

In addition, during re-assembly any rust present on the knuckle or backing plate may be dislodged, and will adhere to the magnetic encoder ring of the new hub assembly. Also, check for any dirt, grease or metal particles on the tip of the sensor. Any of these conditions will cause interference within the magnetic field and will result in the pulse being erratic or blocked altogether.

Note: It's imperative  
to remove loose  
rust to prevent an  
excessive air gap.
