# 2001-2007 Ford 2.0 / 2.3L Duratech Engines

## Engine Install Bulletin

### **NO START / POSSIBLE ENGINE DAMAGE** **SPECIAL SERVICE TOOLS**

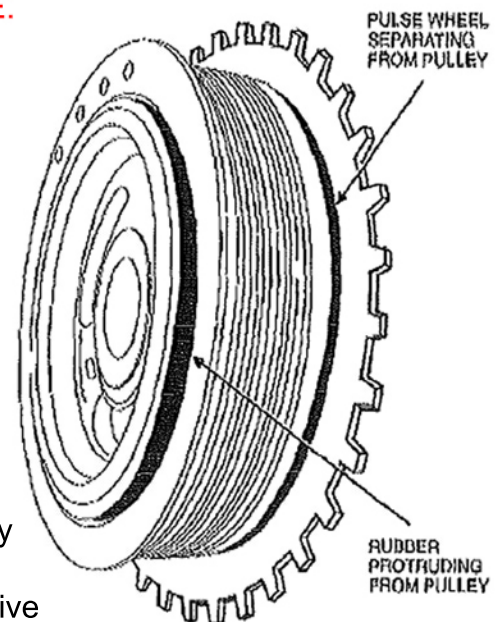
Inspect the crankshaft pulley for rubber protruding from the pulley loose pulse wheel, or bent tabs on pulse wheel touching engine front cover. Replace crankshaft pulley with service kit for respective vehicle.
