## Have you experienced an issue with the blower motor speed selection on a Chevrolet Suburban?

Have you experienced an issue with the blower motor speed selection on a Chevrolet Suburban & Silverado (1999–2006), GMC Trailblazer & Envoy (2000–2006)?

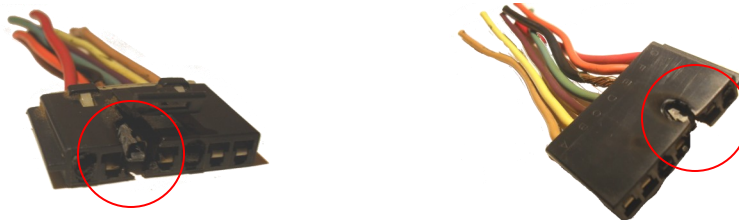
The most likely problem is the blower motor resistor has failed and will require replacement. Another common problem is the electrical connector to the blower motor resistor may have a short causing the socket connection to melt.
