CARDONE ProTech

Different Number of ECC Pins – Problem or Not?

Application Engine Control Computers.

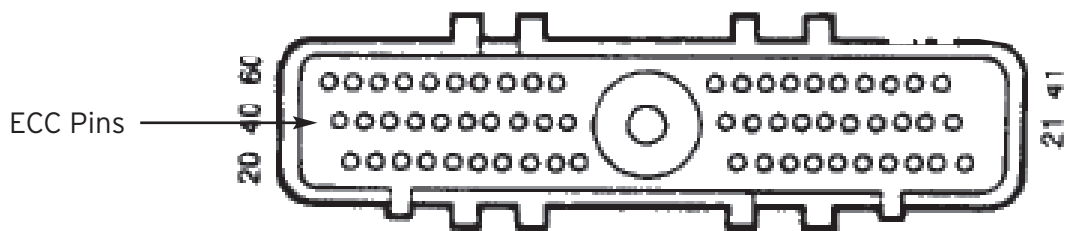
Problem The number of connector pins on the original ECC and the CARDONE replacement unit do not match.

Cause The Original Equipment Manufacturer used different number of pins for the same part number. Some pins are fake or not used in every application.

Typical ECC Connector

Solution Don't waste time wrestling with the problem. Always match the original computer service number to the CARDONE part number in the back of the catalog. If correct, the replacement unit will fit and function for the listed application.

Note When matching the original FORD ECC part number, see the application footnote in the cross reference guide.
