Failed Booster Seal Causes Master Cylinder Leaks

Application Vehicles equipped with power brake booster assemblies.

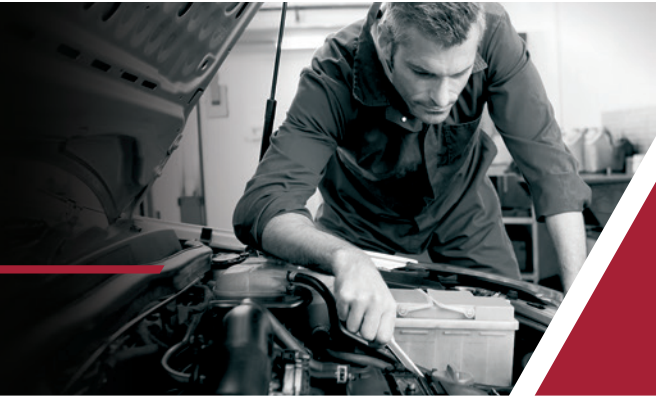
Problem Chronic master cylinder failure due to fluid leaking past secondary seal in the master cylinder bore.

Cause A defective master cylinder pushrod seal in the power brake booster allowing vacuum to draw fluid past secondary seal of the master cylinder.

Solution Replace both master cylinder and power brake unit.
