## IB104

# Clutch to Transmission Housing Interference

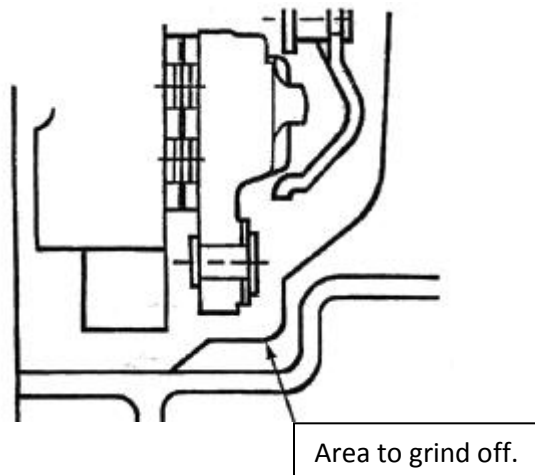
Some of these vehicles may be equipped with a ZF factory remanufactured transmission. The transmission identification tag starts with F2TA. These transmission housings have a thicker casting in the clutch housing area than the original transmission. You may need to grind off  $\frac{1}{4}$ " of the air dam at the 7 o'clock area for clutch clearance. This modification can be done by removing the dust cover for access.
