DID YOU KNOW?

ADVICE FOR THE PROFESSIONAL

Overview

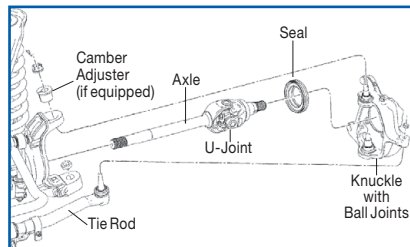
Remove the wheel hub, bearing and axle.

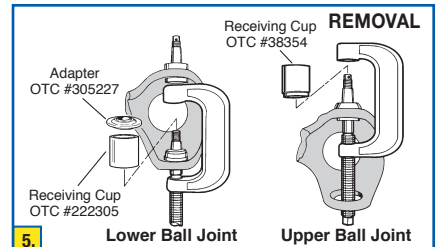
Then remove the **upper** ball joint from the knuckle, utilizing a ball joint press and appropriate receiving cups and adapters. (FIG 5)
