TIPS AND TRICKS:

Why Checks Should Be Made Before Fitting

All applications **Part numbers** All Valeo A/C COMPRESSORS

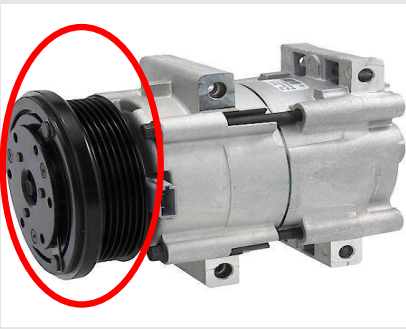
Check the pulley size the off set and belt type to the original compressor
