IB239

Clutch Repair on Vehicles Equipped With a Concentric Slave Cylinder (CSC)

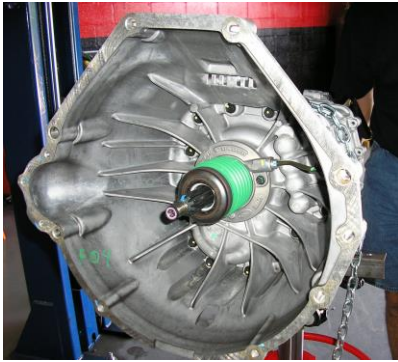
Figure 1

The CSC is a self contained, hydraulic cylinder and release bearing assembly that is mounted **inside** (Figure1) the bell housing.

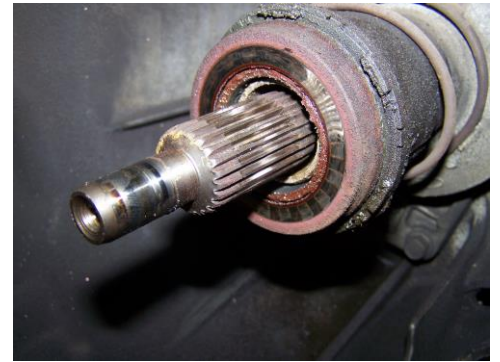
Figure 3

- Fluid leakage from the old CSC unit (Figure 3).
- Clutch release problems.
- Reduced service life of the entire clutch system.

To repair the vehicle properly, always install a new, complete CSC assembly (Figure 2) when replacing the clutch. Replacing only a clutch release bearing onto the used and worn CSC body can result in:
